Reducing risk of corrosion failure on instrumentation lines

By selecting Tungum[®] Tubing a leading deepwater project company was able to reduce the risk of tube line failure due to saltwater corrosion while also cutting downtime and refit costs.

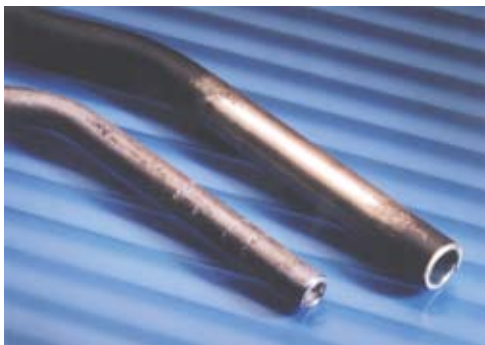
Tungum tube (top) remains unscathed despite more than 10 years marine exposure on a semi-submersible support vessel. Stainless steel (bottom) showed both crevice and chloride pitting after barely five years in the same environment.

Subsea 7 chose Tungum tubing for its proven history in seawater environments and its resistance to stress and crevice corrosion. The tube possesses a natural protection mechanism whereby, on exposure to salt spray, a very thin oxide coating is generated over the exposed service, no more than two thousandths of an inch thick, when complete. The tube becomes discoloured and it may even have a verdigris coating, but under the oxide layer the tube material is perfect and will remain so for a very long time.

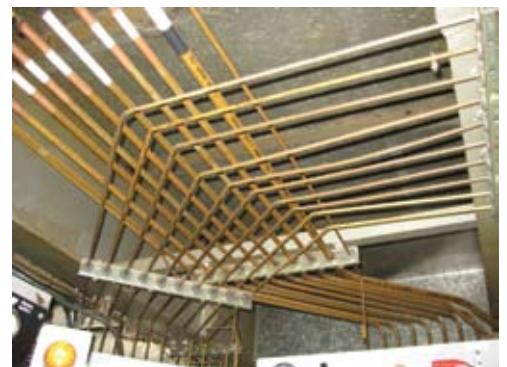
Tungum tube lines after 26 years on Rockwater 1

Subsea 7 installed Tungum for the instrumentation lines and was pleased with the performance of the tubing. Tungum tubing now plays a major role in eliminating downtime of many systems in this vessel as it is highly resistant to seawater and its atmosphere, offering outstanding serviceability, even at intermittent duty in the highly corrosive ‘splash’ zone. The photo on the right was taken in 2010 and shows the tube still in good condition and performing well after 26 years of service!
