## Reducing risk of corrosion failure on hydraulic, potable water and chemical lines

By selecting Tungum® Tubing a leading deepwater project company was able to reduce the risk of tube line failure due to saltwater corrosion while also cutting downtime and refit costs.

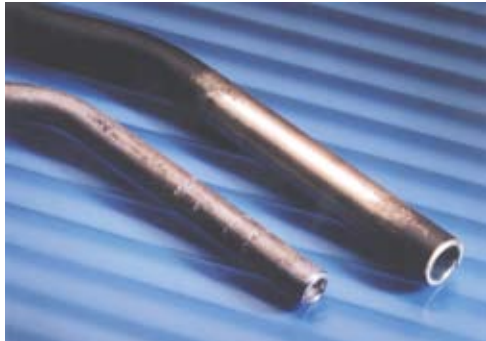
Tungum tube (top) remains unscathed despite more than 10 years marine exposure on a semi-submersible support vessel. Stainless steel (bottom) showed both crevice and chloride pitting after barely five years in the same environment.

Baker Hughes chose Tungum tubing for its proven history in seawater environments and its resistance to stress and crevice corrosion. The tube possesses a natural protection mechanism whereby, on exposure to salt spray, a very thin oxide coating is generated over the exposed service, no more than two thousandths of an inch thick, when complete. The tube becomes discoloured and it may even have a verdigris coating, but under the oxide layer the tube material is perfect and will remain so for a very long time.

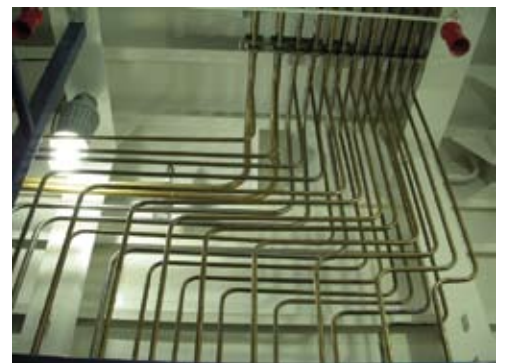
Tungum tube lines on BJ Blue Dolphin

Baker Hughes replaced the corroded lines with Tungum and was pleased with the performance of the tubing. Tungum tubing now plays a major role in eliminating downtime of many systems in this vessel as it is highly resistant to seawater and its atmosphere, resisting both stress and crevice corrosion to offer outstanding serviceability, even at intermittent duty in the highly corrosive splash zone.
